UCRL-AR-143121-07

Lawrence Livermore National Laboratory
Experimental Test Site 300

Compliance Monitoring Program for the
Closed Building 829 Facility

Annual Report
2007

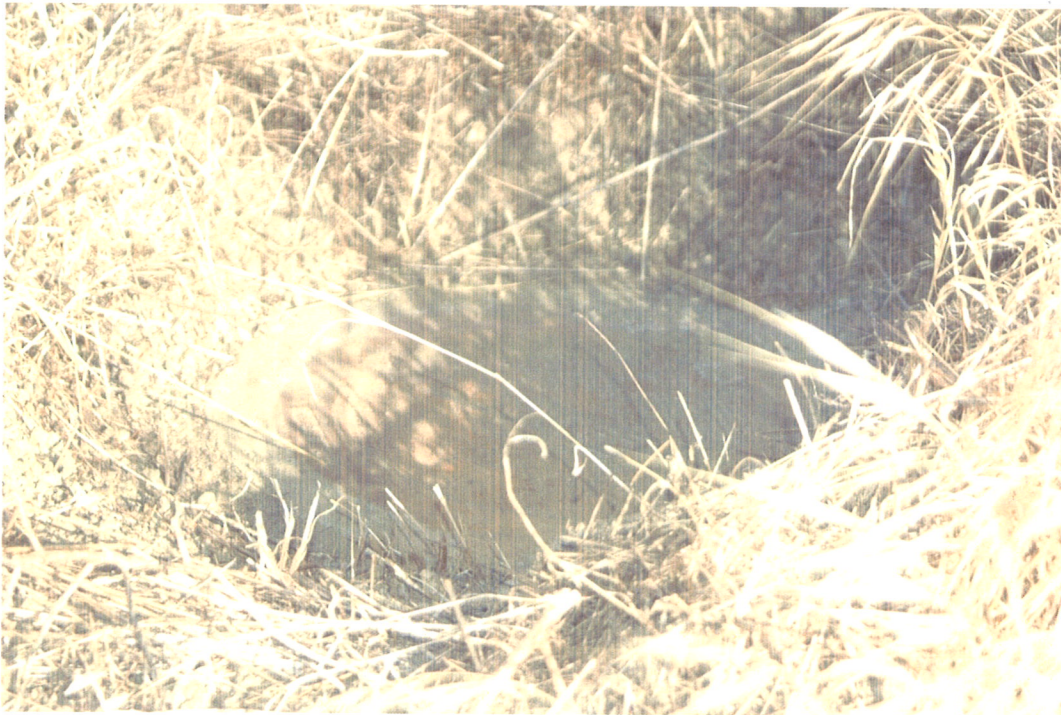
Figure 4 Christy Type Traffic Valve Box

No evidence of subsidence was observed over the pit. A minor depression on the southeast side of the cap was observed during the inspection. It was determined that the depression was not a defect with the cap, but rather soil that covered a Christy traffic valve box used to cover a cleanout access location, see figure 4.

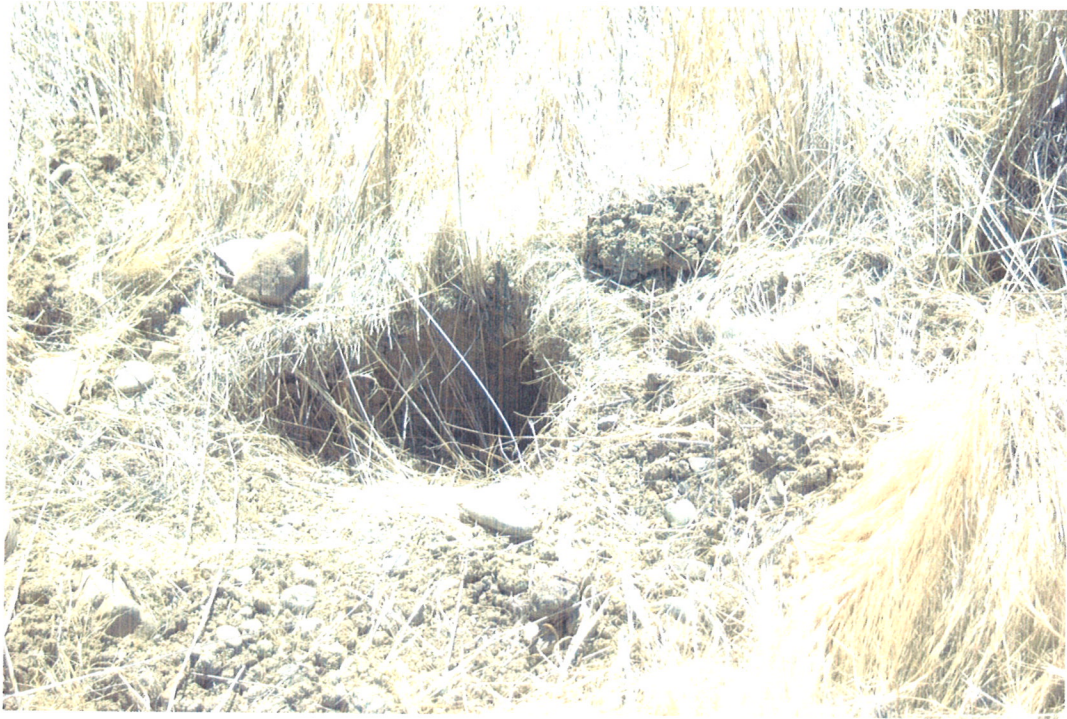
Figure 5 Building 829 Burrowing Animal Hole

A few small burrowing animal holes, approximately 2 inches in diameter, and a few larger burrowing animal holes, approximately 8 inches, see figure 5, were observed on the cap. It is recommended that holes exceeding 18 in. in depth and 6 in. in diameter be repaired.

- Fill in the animal holes exceeding 18 in. in depth and 6 in. in diameter on, the cap and reseed where necessary.
