Lawrence Livermore National Laboratory Experimental Test Site 300

Compliance Monitoring Program for the Closed Building 829 Facility

Annual Report 2021

LLNL Site 300 Building 829 Landfill Cap Annual Engineering Inspection

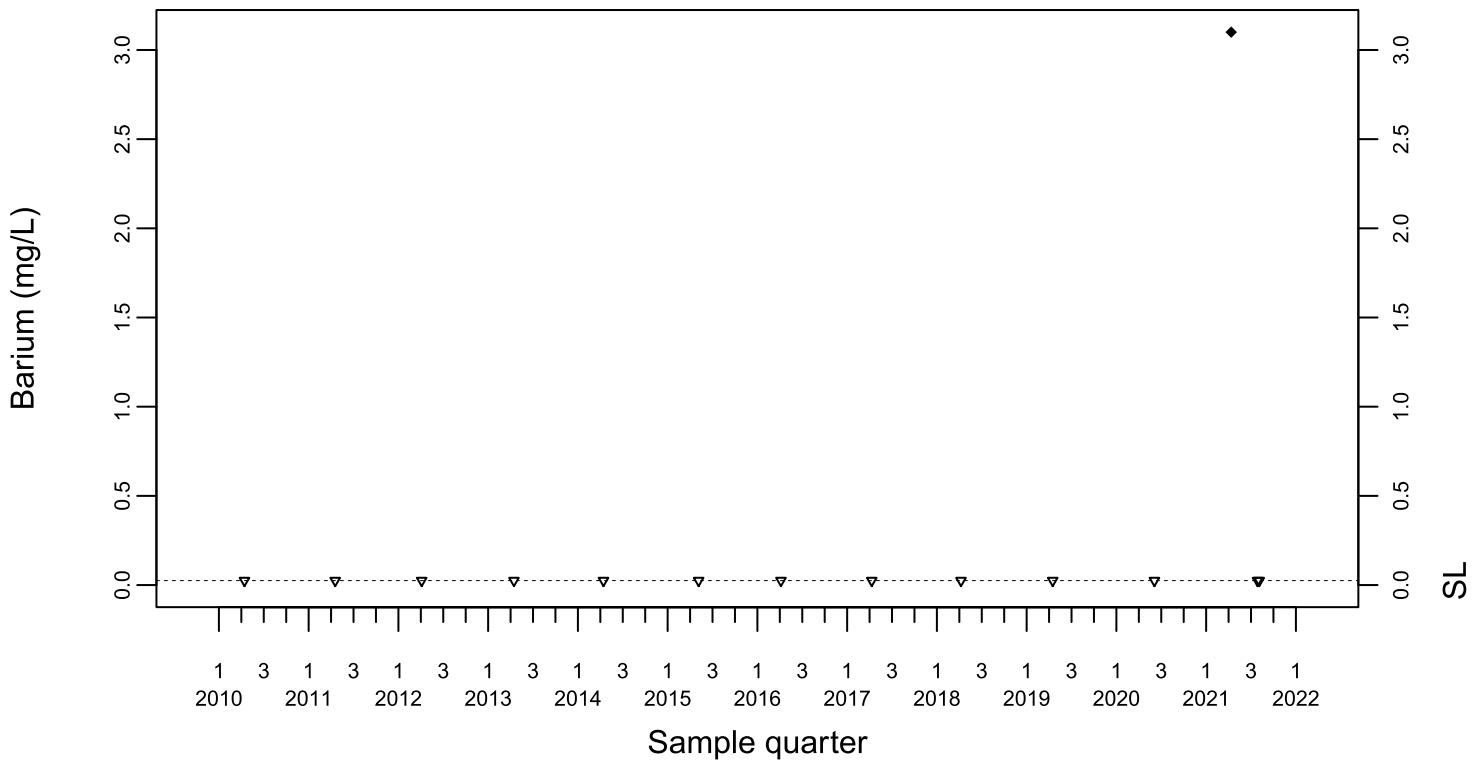
Monitoring Point W-829-22

The 2021 barium concentration at well W-829-22 (3,100 µg/L) (**Table A-3**) significantly exceeded the SL and current RL (both 25 µg/L) (**Table A-1**). However, this result was invalidated after conducting two independent retests. The initial 2021 detection was the first detection of barium at well W-829-22 since monitoring began in 1999. The barium concentration of 3,100 µg/L was several orders of magnitude higher than previous results and the barium concentration was similarly elevated in the duplicate sample (2,100 µg/L). Wells W-829-15 and W-829-1938 were also sampled for barium in April 2021 and concentrations were more consistent with past sampling. Based on historical groundwater sampling at Site 300 and the fact that the initial barium result was invalidated, the initial concentration is likely an anomaly and not caused by an actual barium release from the B829 burn pit. Potential causes of this high initial barium concentration include sample handling issues in either the field or laboratory, analytical instrument issues, or sample mix-up.

SL=0.025

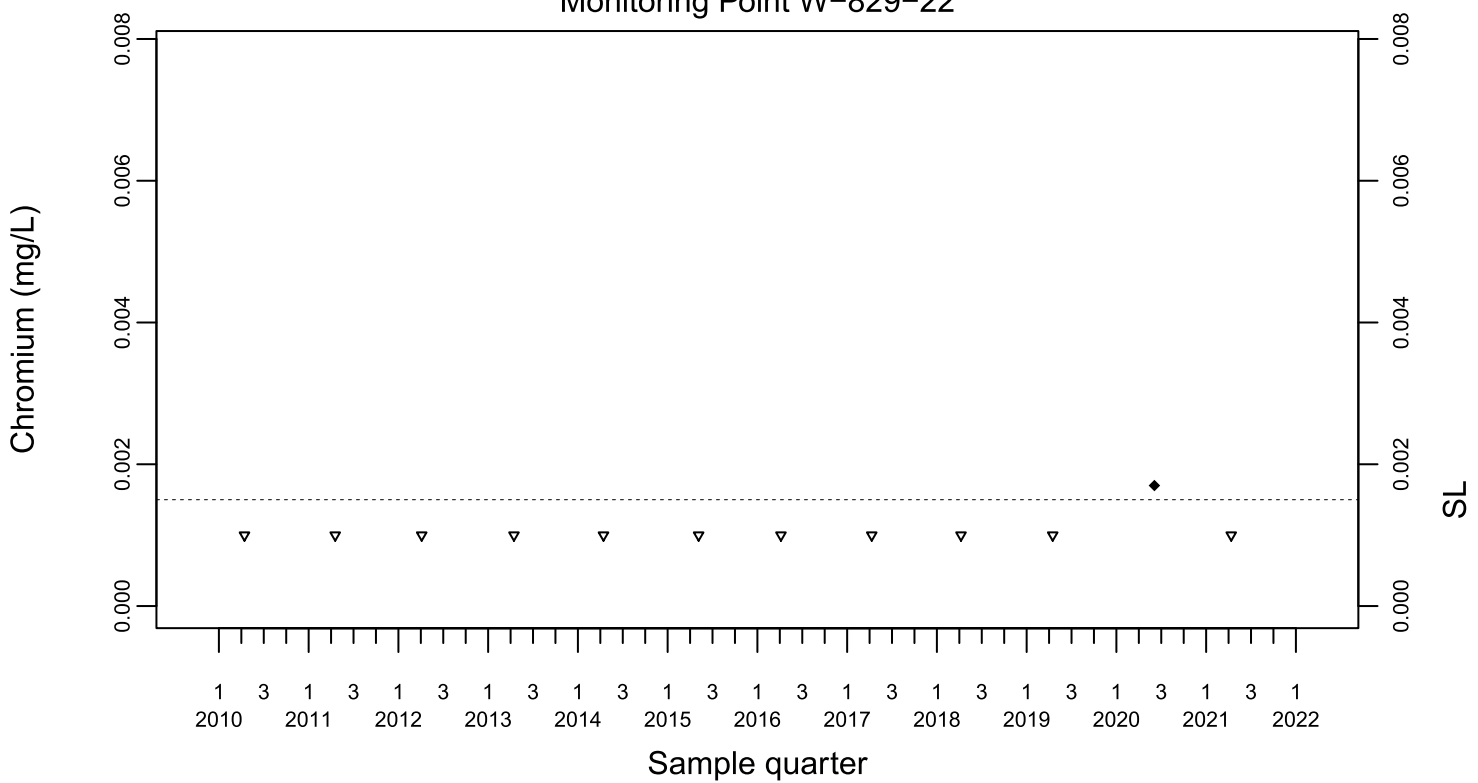
Monitoring Point W-829-22

In 2020, LLNL inadvertently missed a chromium SL exceedance at W-829-22 and the opportunity to resample (Will, 2020). The routine second quarter 2020 chromium result was 1.7 µg/L, which slightly exceeded the SL of 1.5 µg/L (**Table A-1**). Chromium has only been detected four times at W-829-22 since monitoring began in 1999. The only other chromium SL exceedance at W-829-22 occurred in 2003 (2.0 µg/L). In 2021, the concentration of chromium at well W-829-22 was below the 1 µg/L RL, which supports LLNL's continued interpretation that the 2020 chromium SL exceedance was likely the result of local background variability and not an actual chromium release from the B829 burn pit.

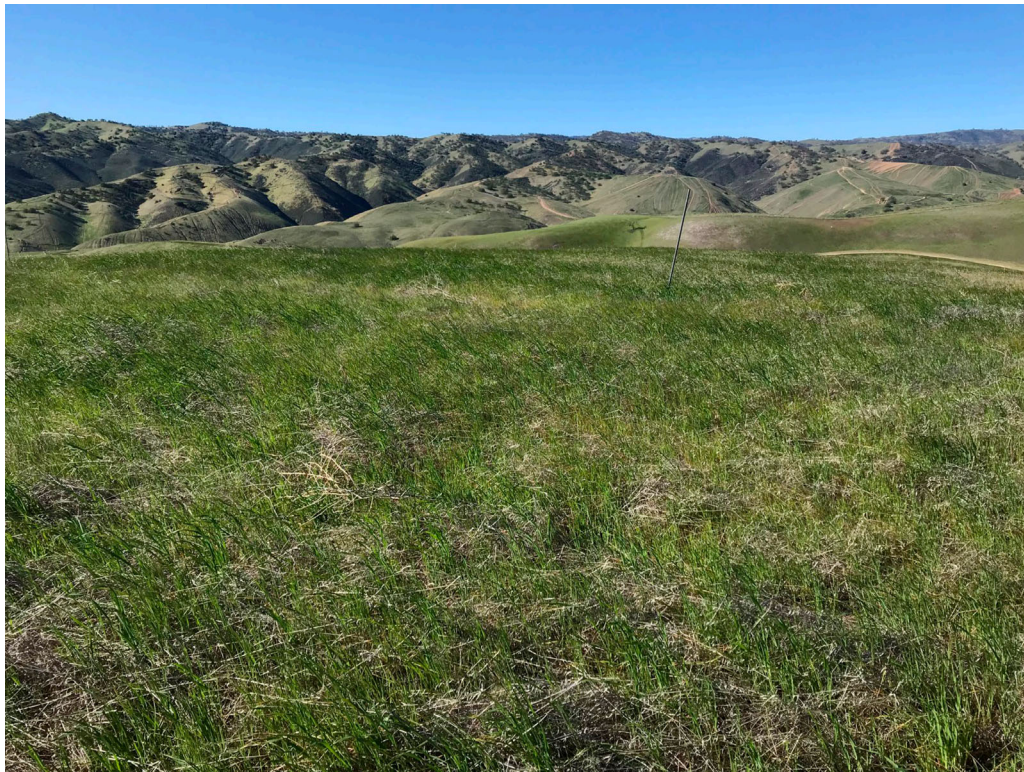
Figure 4 Building 829 Landfill Vegetation Cover Condition

Building 829 landfill cap is in good condition. The vegetation cover is thick and covers the soil cap over the pits; there is no visible erosion of the cap; and the drainage system is in good condition and appears to be functioning as intended. The groundwater monitoring system appears to be in good condition as well. Evidence of accumulation of some vegetative debris in the concrete lined drainage ditch was observed. Based on the inspection, recommendations are provided in section 2-14.

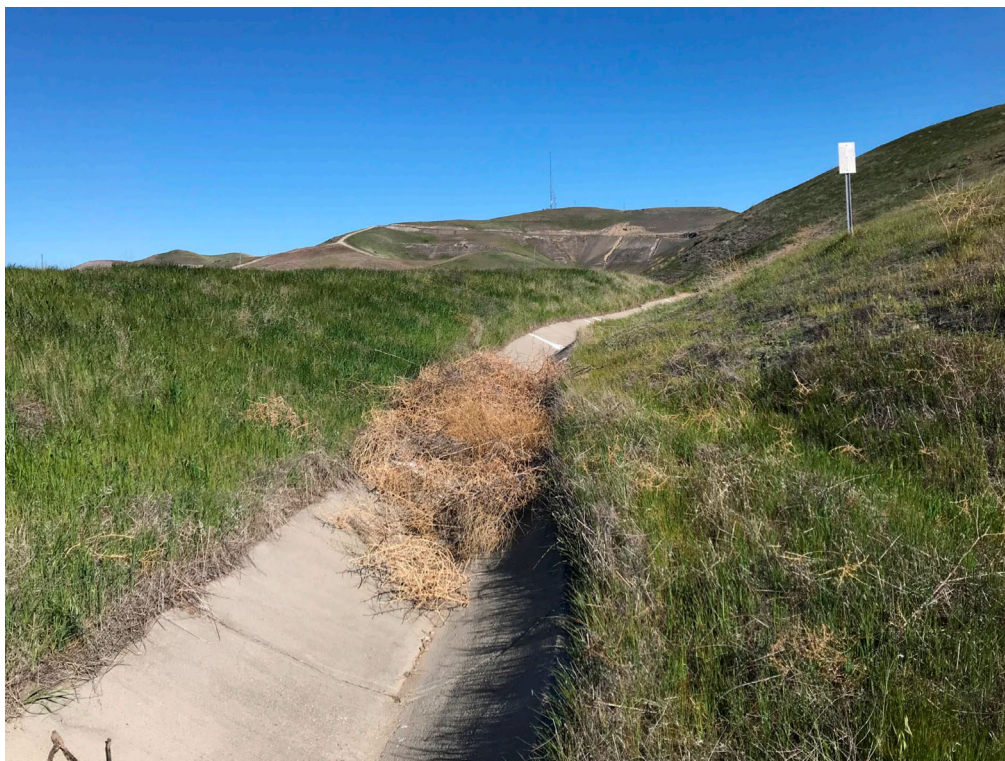
Figure 5 Building 829 Vegetative Debris in Drainage Ditch

Vegetative debris was observed in the concrete lined drainage ditch, see Figure 5. It is recommended that the vegetative debris be removed.

The required annual cap inspection by a California-registered PE was completed on March 29, 2021. A copy of the *Building 829 Landfill Cap Annual Engineering Inspection* (Moore, 2021) is included in this report as **Appendix D**. The inspection included a review of existing documentation on the cap as well as an on-site inspection. All items required to be inspected under Title 22 of the CCR, Part 66264.228(k) were noted to be in good condition, except for evidence of vegetative debris accumulation in the drainage ditch. The only recommendation made in the annual engineering report was removal of the vegetative debris, which was ordered by the Site 300 Manager's Office and completed in 2021.

- Remove vegetative debris from the drainage ditch.
